Mountaineer Inspection Services, LLC

Home Inspection Report

100 Main Street

Inspected on Sat, Apr 14 2012 at 10:00 AM

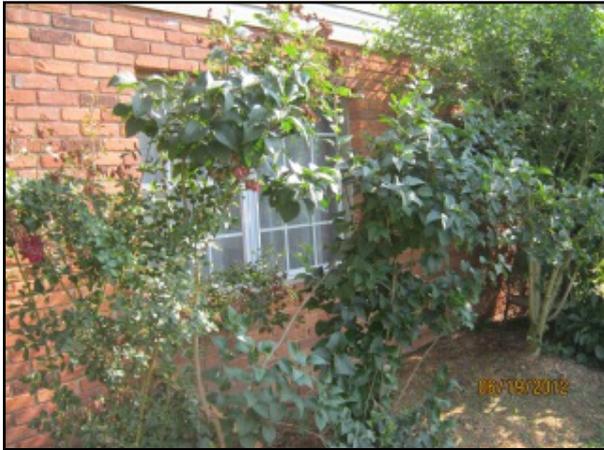
Figure 4-1

The shrubbery is nature. Recommend that all shrubbery be kept back 12" from siding to prevent damage.

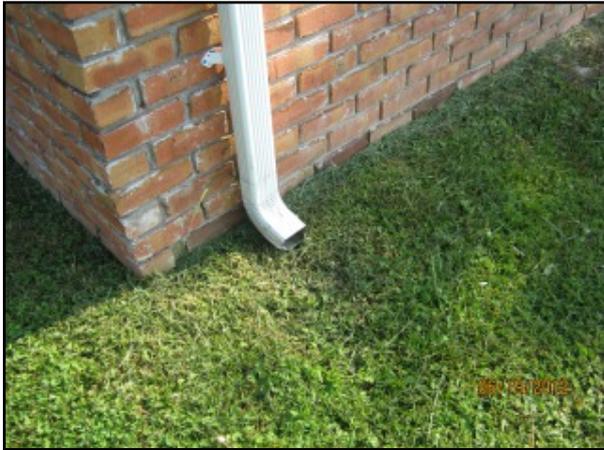
Figure 5-1

The gutter on the left side of the house does not extend away from the house. Water can collect around the foundation causing damage. Recommend the gutters be extended to drain away from the house.

- 1) The gutter on the left side of the house does not extend away from the house. Water can collect around the foundation causing damage. Recommend the gutters be extended to drain away from the house.
- 2) The deck handrail is not bolted to the house at the corner and is loose. Recommend the rail be securely attached to the house.
- 3) There was exposed wood framing around the window on the hot tub room window. Recommend installation of exterior trim material to protect this area.

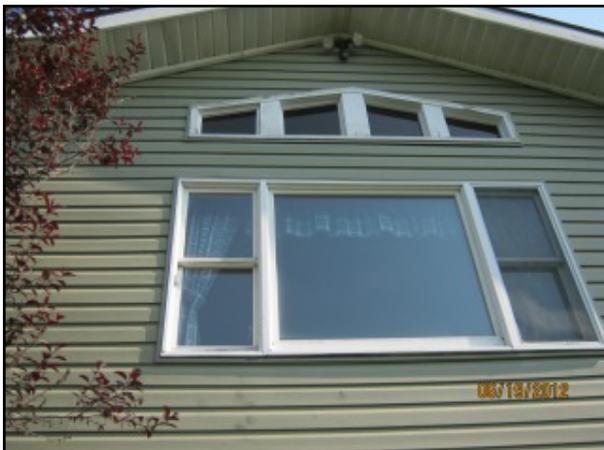
Figure 6-1

The wood trim around the upper window is peeling. Recommend prepping and paint to prolong the life of the wood trim.

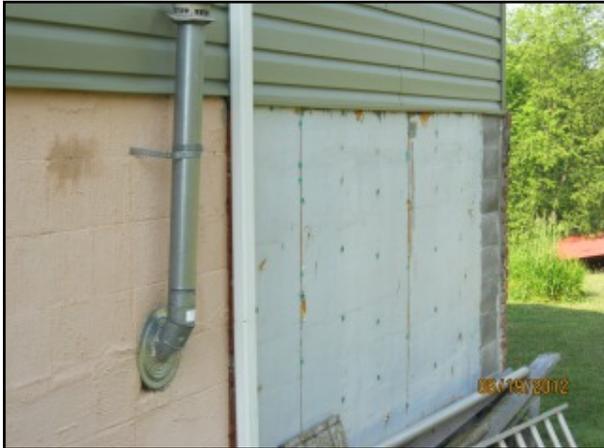
Figure 7-1

There is an area of the storage located off the basement that only has the silver insulation board installed. These material is not water resistant and will cause damage to the framing over time. Recommend this area be completed with a weatherproof material.

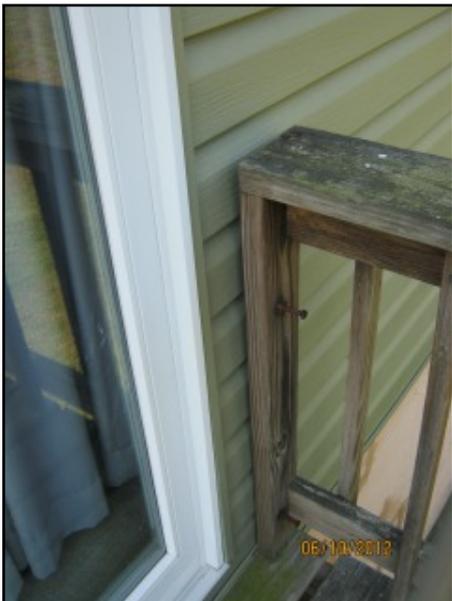
Figure 8-1

**Comment 8:**
The deck handrail is not bolted to the house at the corner and is loose. Recommend the rail be securely attached to the house.

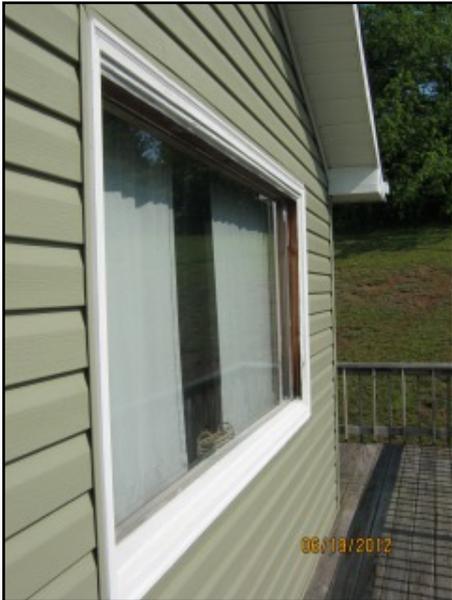
Figure 9-1

There was exposed wood framing around the window on the hot tub room window. Recommend installation of exterior trim material to protect this area.

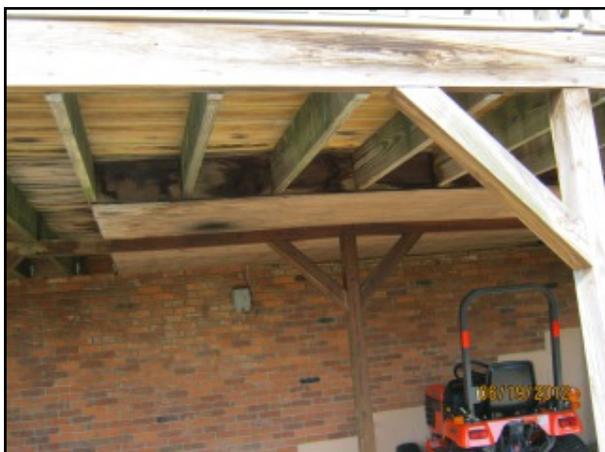
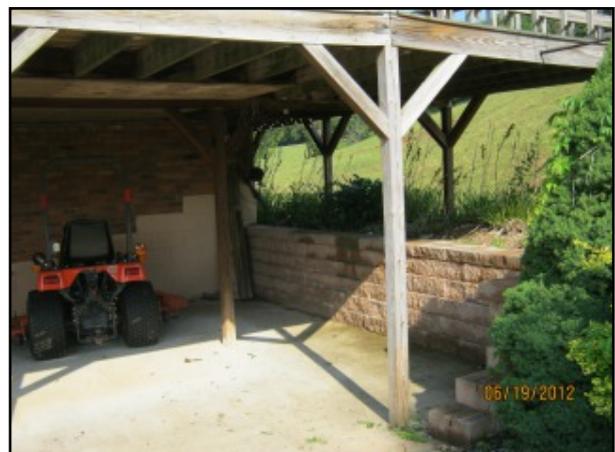
The deck structure supporting the upper enclosed porch appears to adequately supported. The center 4x4 running horizontally across the center supports is not the best choice for this application. If the hot tub is to be used, it is recommended a properly designed beam be installed in place of this 4x4. Consult a structural engineer for proper sizing.

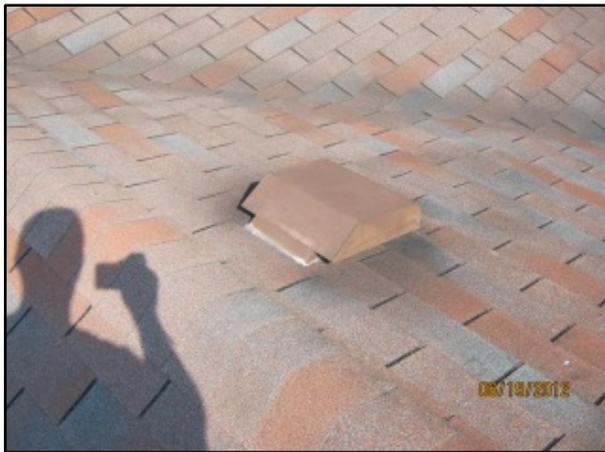
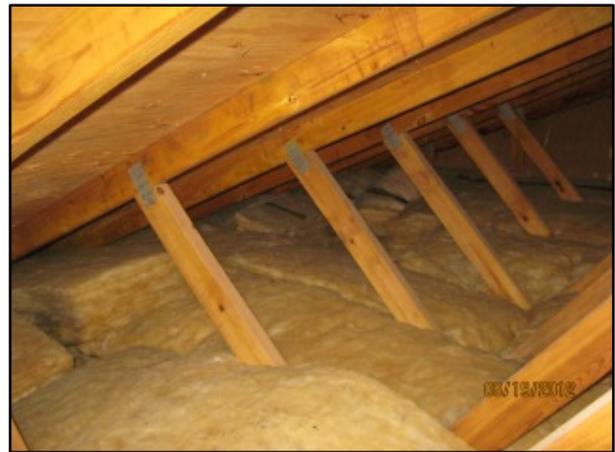
i Comment 11:
The roof is vented with a few vents located near the ridge. The flow from the vented soffit is blocked by the insulation. Inadequate ventilation will decrease the life of the shingles. Recommend installation of styrofoam baffles where accessible for installation.

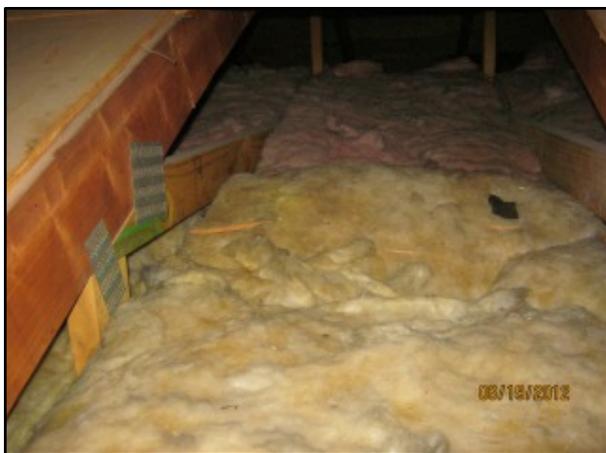
Figure 12-1

Only a portion of the attic above the master bedroom was accessible for inspection. The remainder of the attic was not inspected due to inaccessibility.

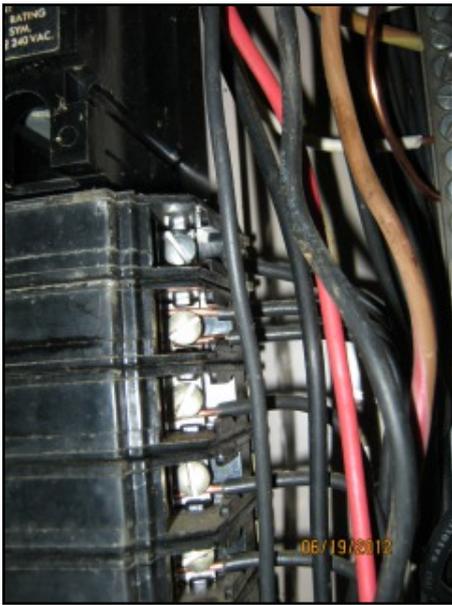
Figure 13-1

One or more of the breakers have multiple wires under a single connection screw. Multiple wires under the same screw can expand/contract at different temperatures and loosen causing a hazard. Recommend additional breakers be installed and the circuits be separated.

- 4) One or more of the breakers have multiple wires under a single connection screw. Multiple wires under the same screw can expand/contract at different temperatures and loosen causing a hazard. Recommend additional breakers be installed and the circuits be separated.
- 5) An outlet in the master bedroom and several outlets in the basement ceiling did not have covers. This is a shock hazard. Recommend all missing outlet covers be replaced.
- 6) The outlet to the right of the kitchen sink showed reversed wiring when tested. Recommend this wiring be corrected.
- 7) The outlets in the front left bedroom of the new addition tested as open ground. Recommend an electrician check and correct the wiring.
- 8) An unsecured wire termination was observed in the ceiling in the basement near the furnace. The should be terminated in a junction box to prevent a fire hazard.

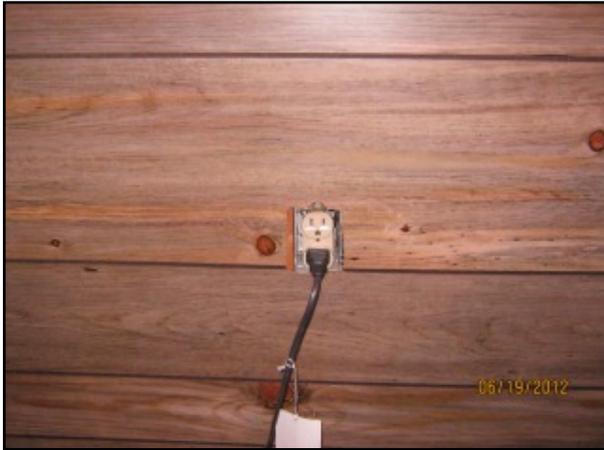
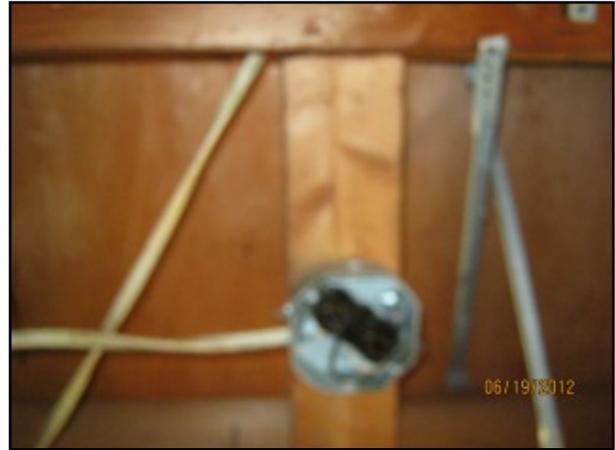
An outlet in the master bedroom and several outlets in the basement ceiling did not have covers. This is a shock hazard. Recommend all missing outlet covers be replaced.

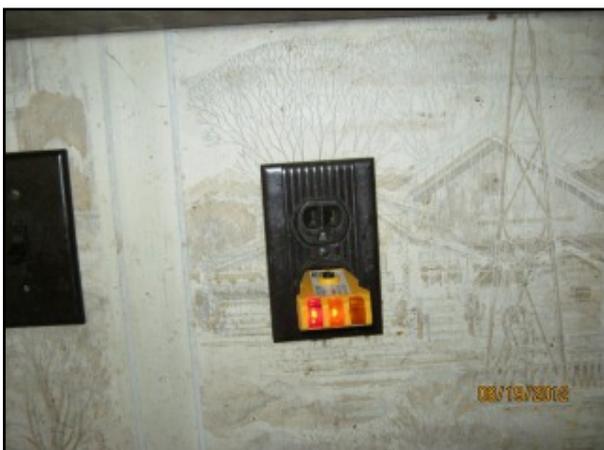
Figure 17-1

The outlet to the right of the kitchen sink showed reversed wiring when tested. Recommend this wiring be corrected.

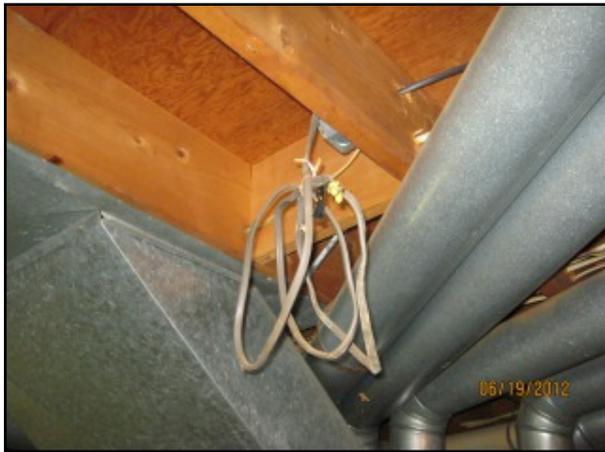
Figure 20-1

An unsecured wire termination was observed in the ceiling in the basement near the furnace. The should be terminated in a junction box to prevent a fire hazard.

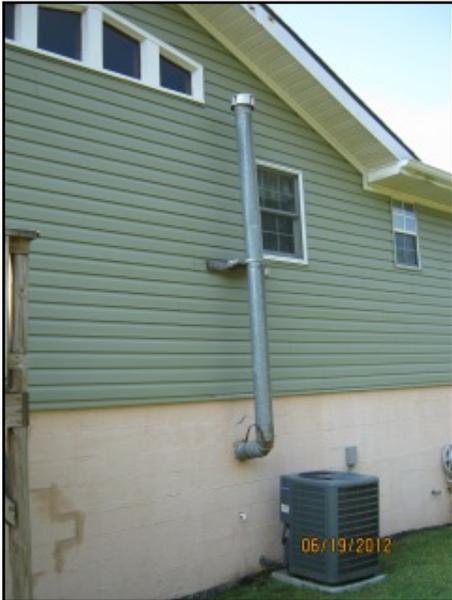
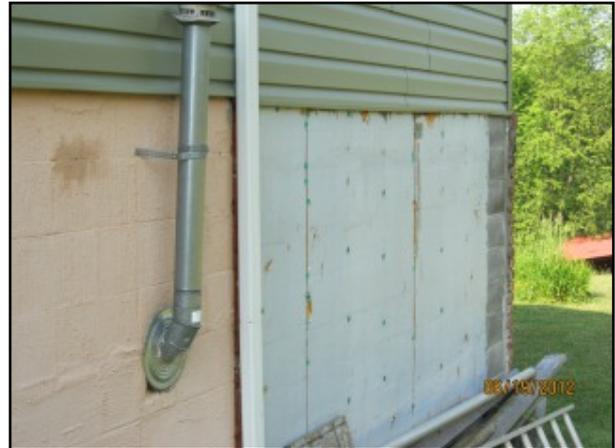
The furnace vent and the hot water heater vent do not extend above the roof line. Accepted building practices recommend these vents extend a minimum of 12" above the roof line. Recommend these vents be extended to the above recommendations.

9) The furnace vent and the hot water heater vent do not extend above the roof line. Accepted building practices recommend these vents extend a minimum of 12" above the roof line. Recommend these vents be extended to the above recommendations.

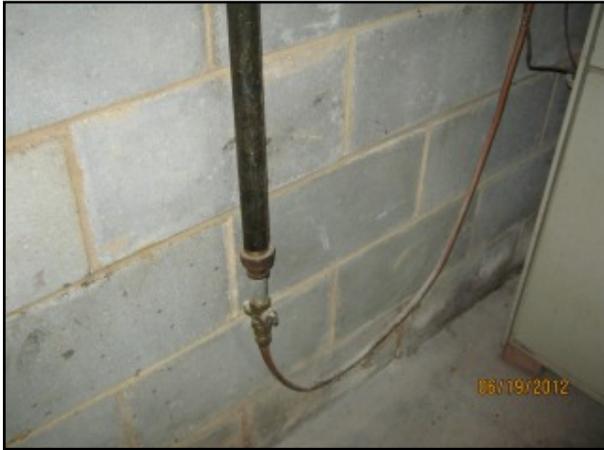
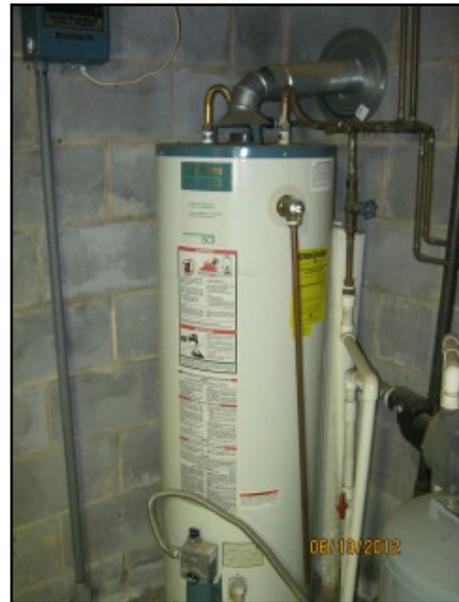
No drip loop or sediment trap was installed on the gas supply line to the water heater and the furnace. This helps to prevent excess moisture from entering the heater. Recommend installation of a drip loop on both units.

10) No drip loop or sediment trap was installed on the gas supply line to the water heater and the furnace. This helps to prevent excess moisture from entering the heater. Recommend installation of a drip loop on both units.

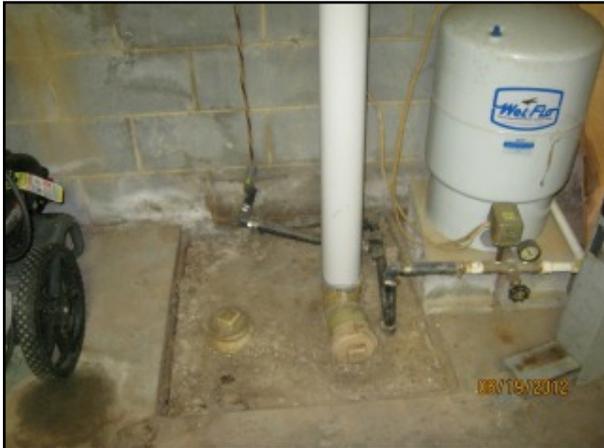
Figure 23-1

The pump for the well water was not tested. This system is used for an outside water source per the homeowner.
